HELMETTA DAM

NJ 00794

PHASE 1 INSPECTION REPORT
NATIONAL DAM SAFETY PROGRAM

REPT. NO: DAEN/NAP - 53842/NJ00794 - 81/08
AUGUST 1981

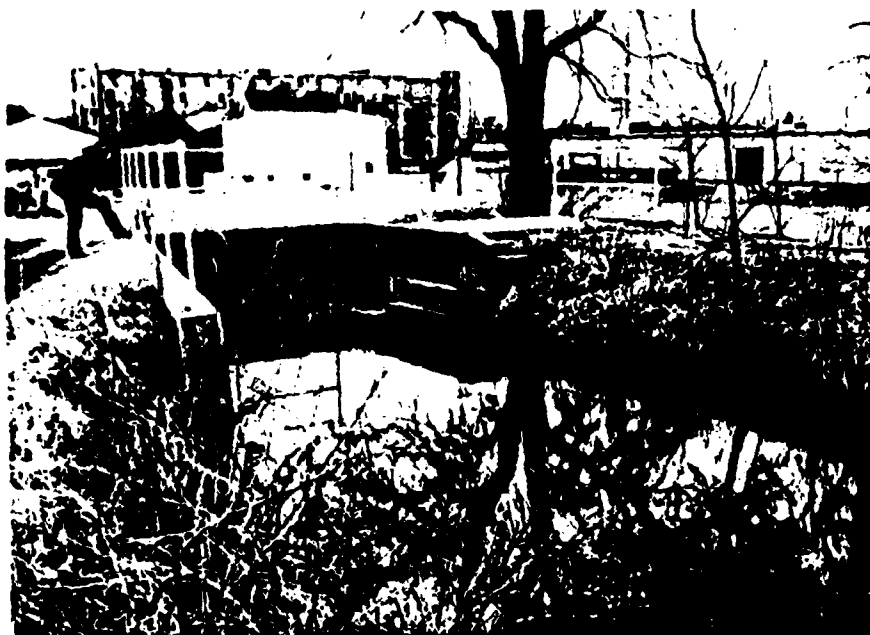
View from u/s looking into overflow channel at u/s end of pipe section spillway on left bank (circular cover at u/s end of pipe.)

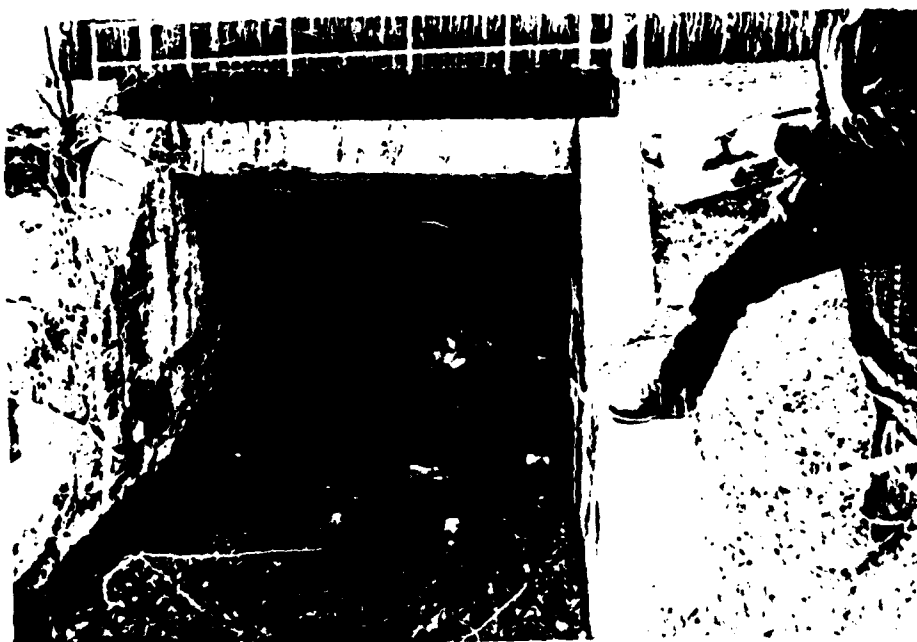
Looking u/s at d/s end of circular pipe spillway - note debris.

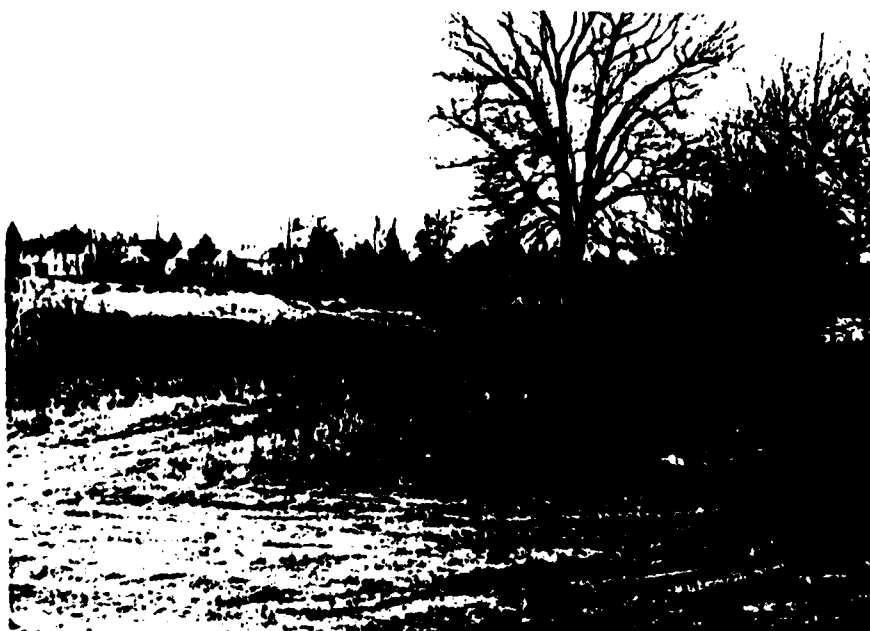
a. Visual Observations. The soft, wet area and seepage at the downstream toe of the dam is indicative of seepage through and under the dam, which, if not properly controlled, could lead to failure of the dam by piping and sloughing of the downstream slope. Serious erosion on the upstream slope of the dam at the waterline, if allowed to continue, could result in eventual breaching of the embankment. Most of the crest of the dam which is bare of vegetation would be susceptible to erosion if the dam were overtopped, which might, in turn, lead to breaching of the dam. Trees growing on the upstream and downstream slopes may cause seepage and erosion problems if the tree blows over and pulls out its roots, or if a tree dies or its roots rot.

View looking across dam d/s face. Very large tree growing on dam crest.

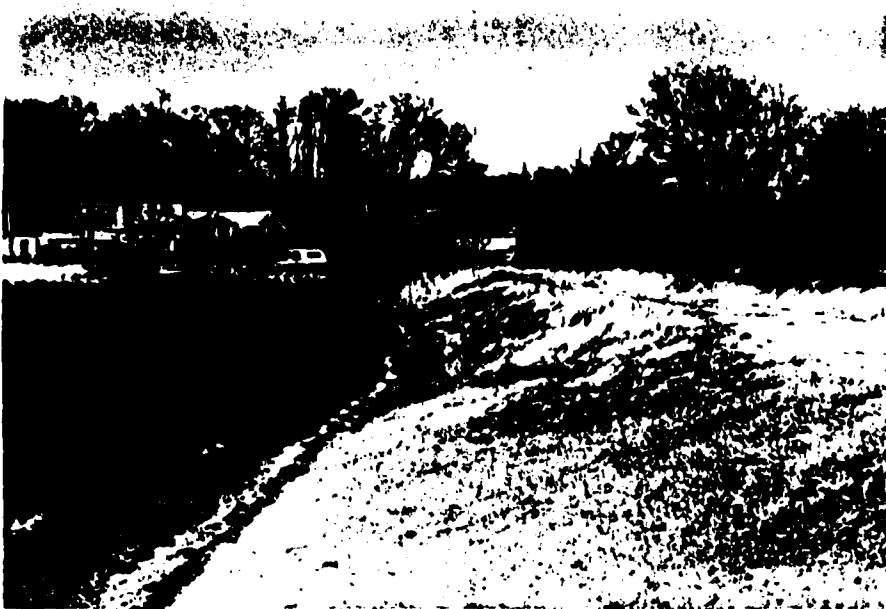
View from location of large concrete block on upstream face looking toward left side of dam. Note extensive erosion along upstream face.

(3) Design and oversee repairs for the erosion of the upstream slope of the dam and design and specify erosion protection for the upstream slope of the dam.
